Situation Photo Log

Friday, March 23, 2012

Kalamazoo River / Enbridge Spill

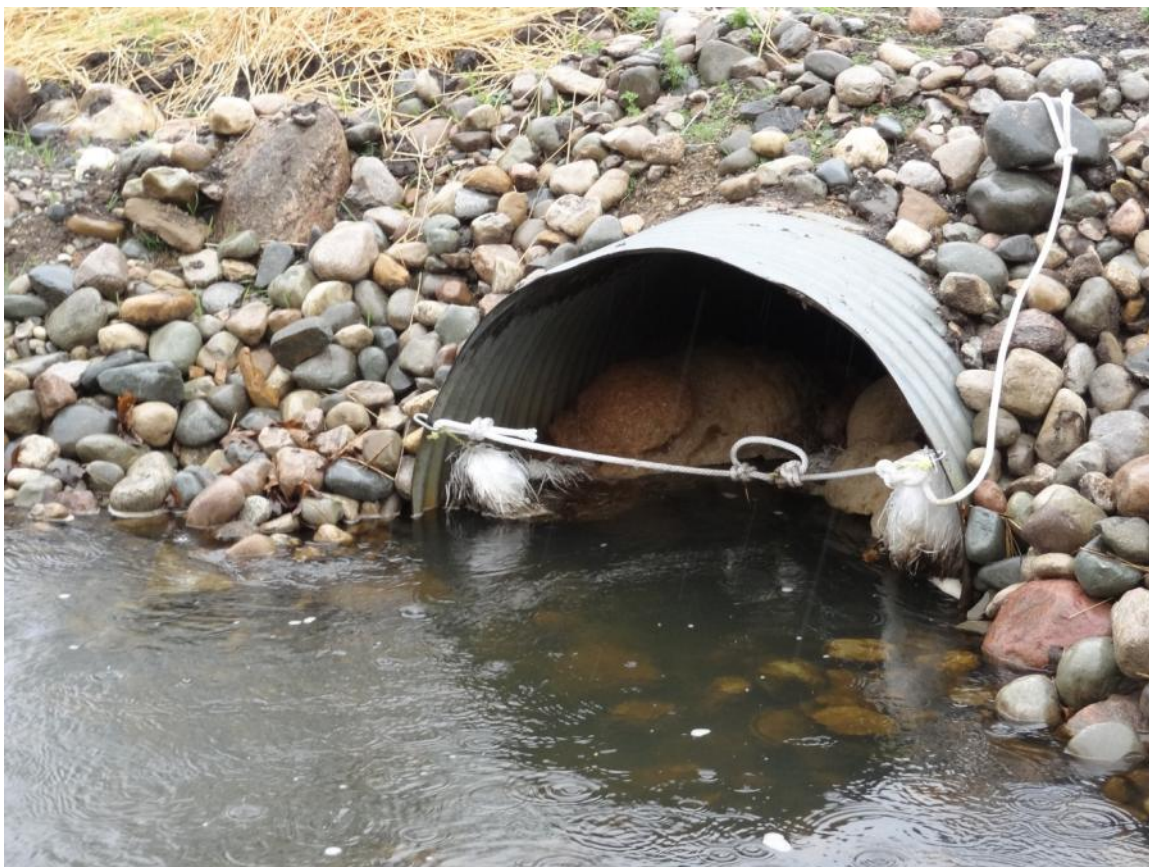
1. Talmadge Creek, snare boom observed in the culvert at A Drive.

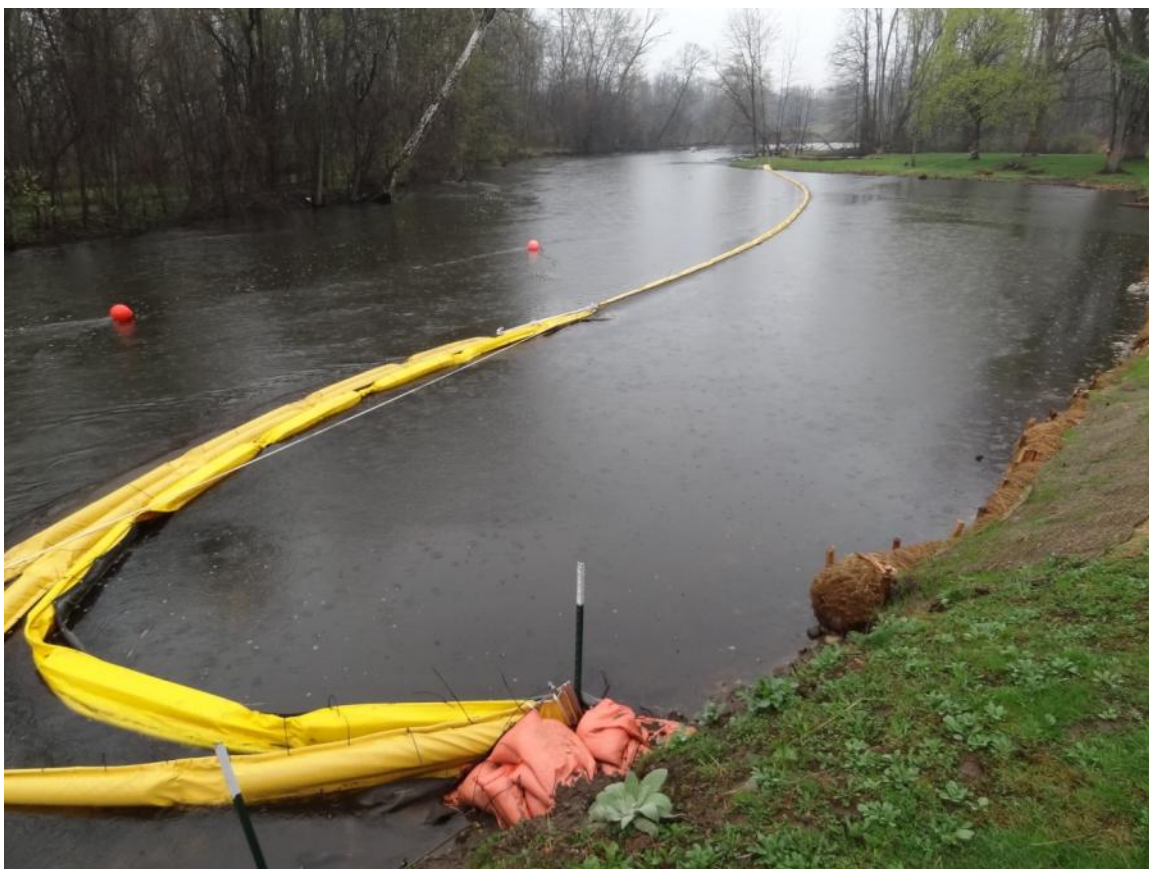
2. Confluence no turbidity or sheen observed.

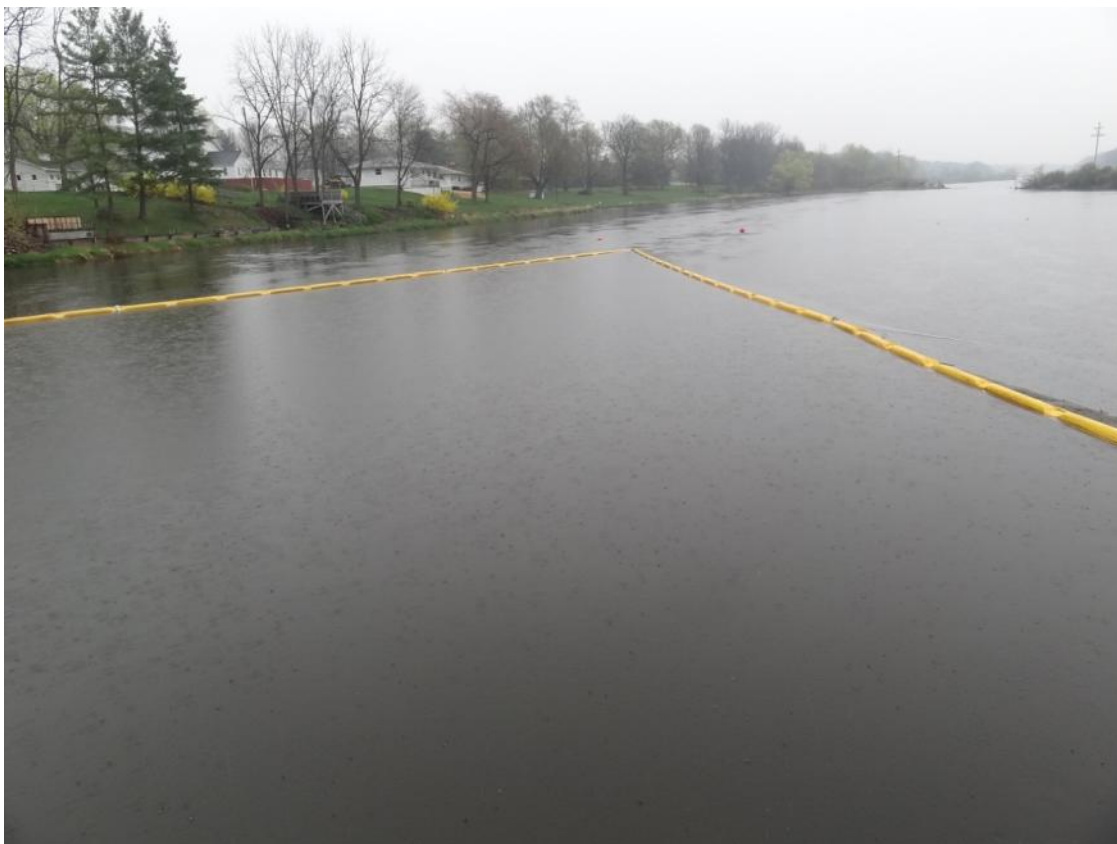
3. Ceresco Dam boom.

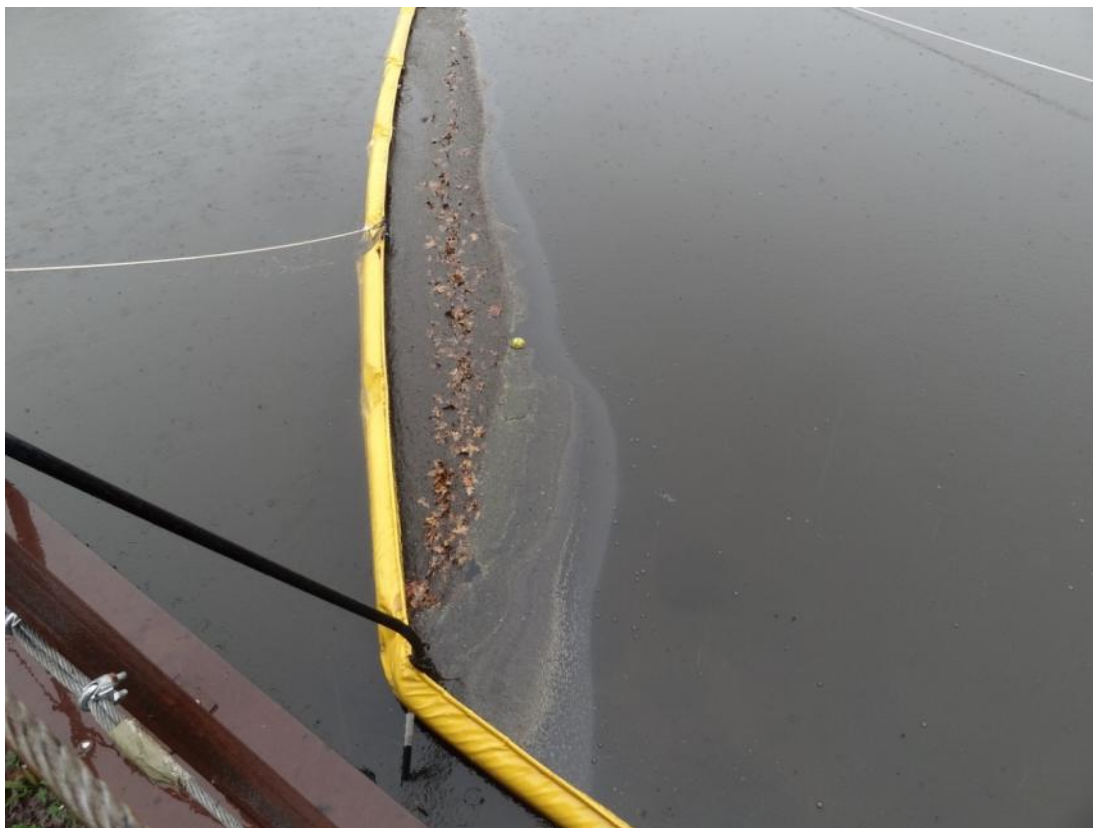
4. Ceresco Dam sheen collecting in boom.

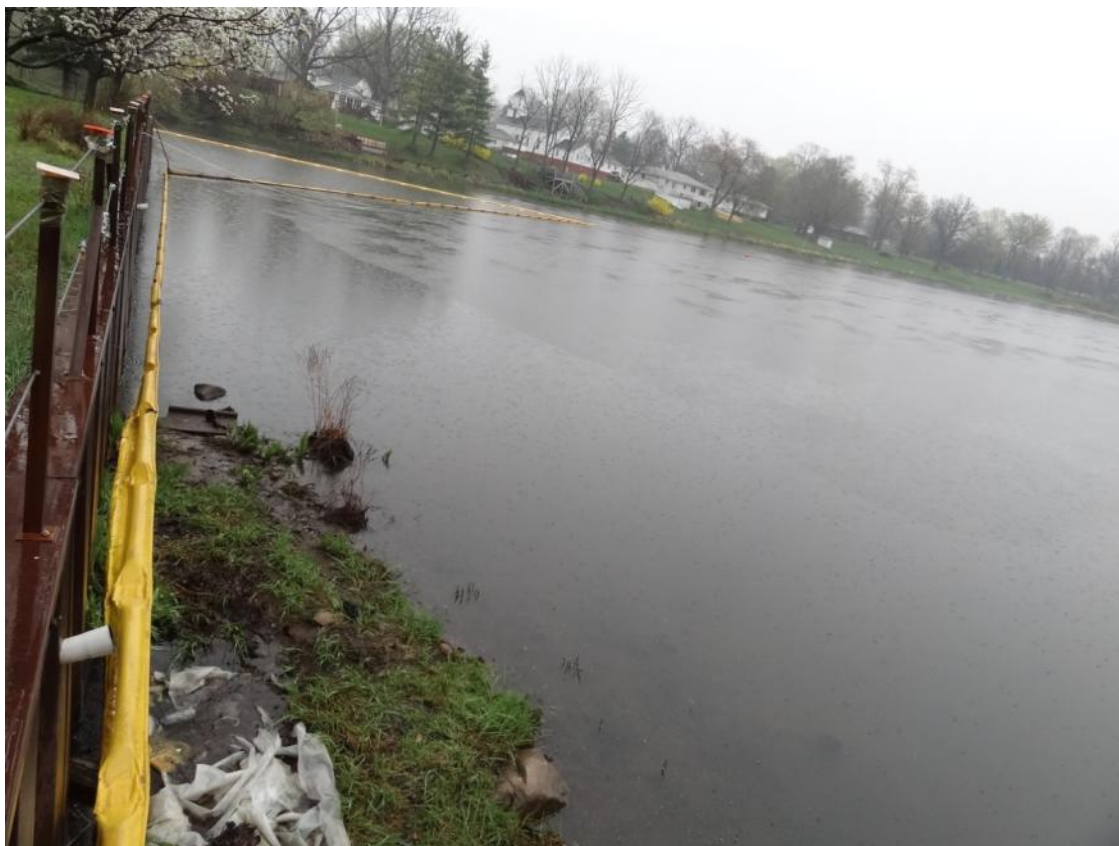
5. Ceresco Dam boom.

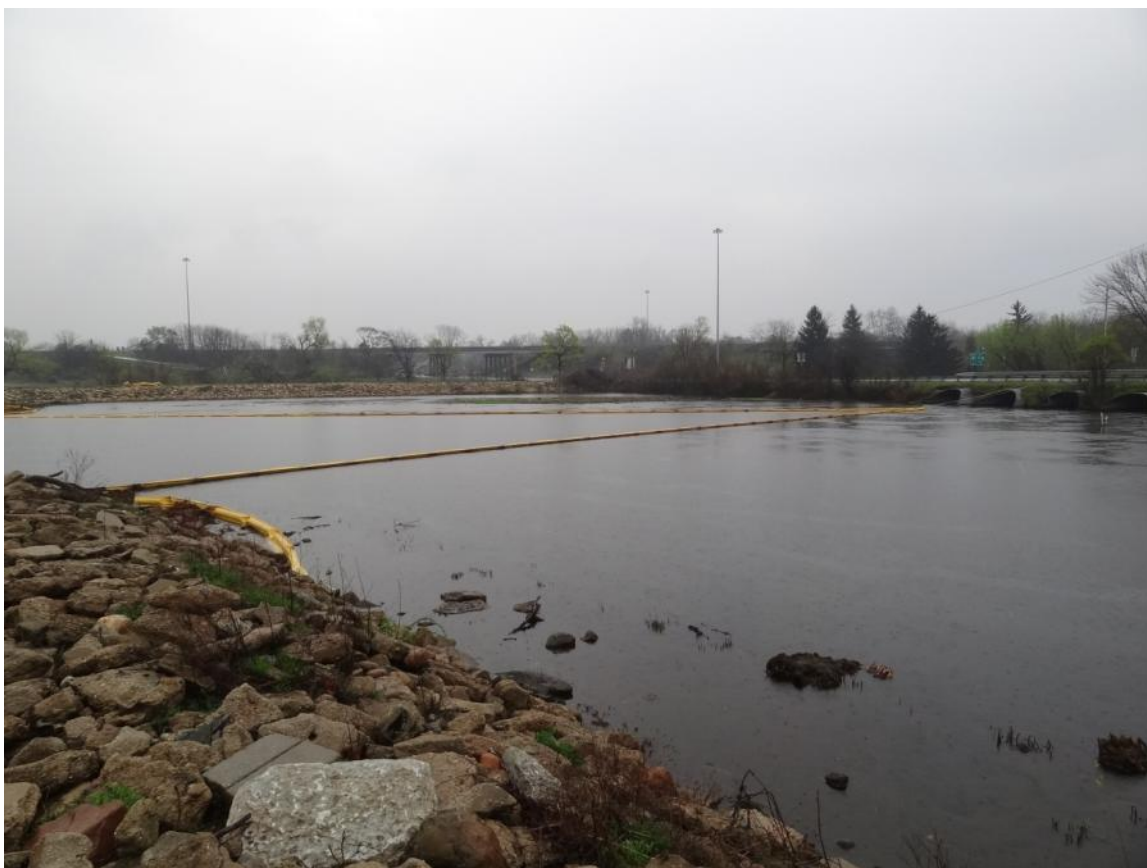
6. MP15.75 boom deployed above the Battle Creek spillway.

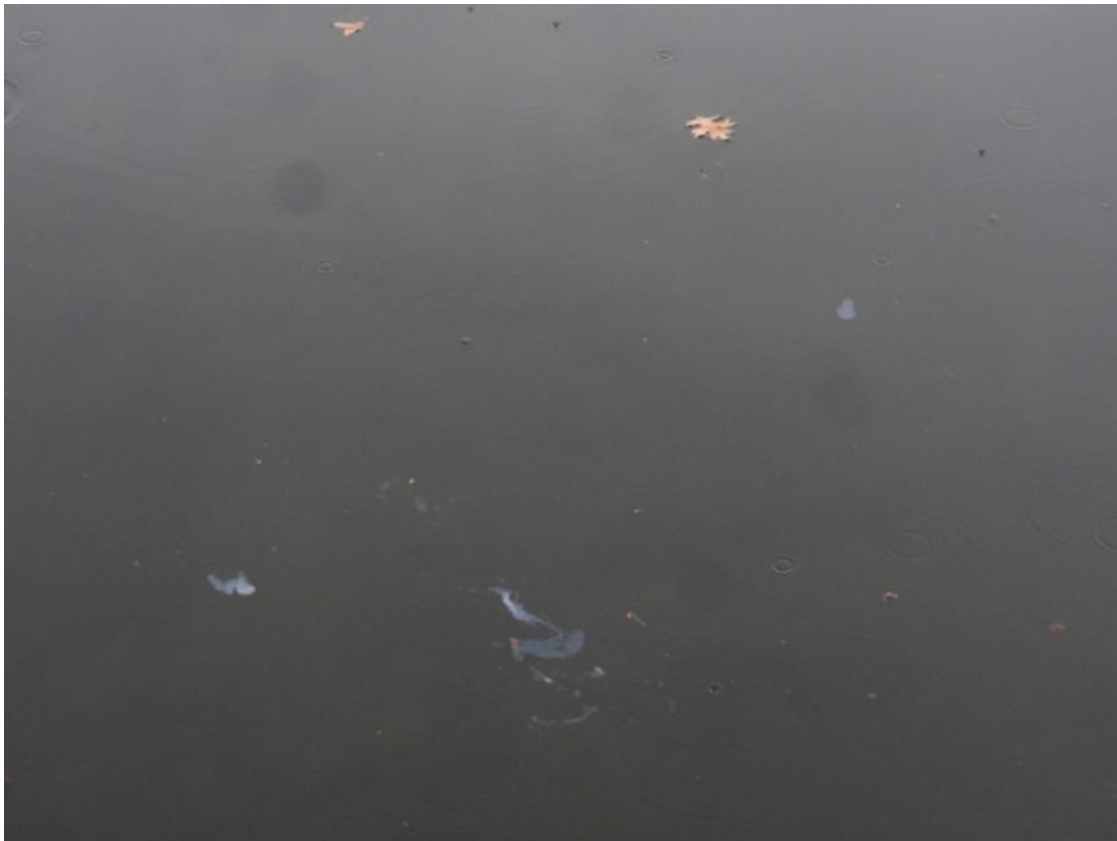
7. MP14.75 C5 Boat Launch sheen observed.

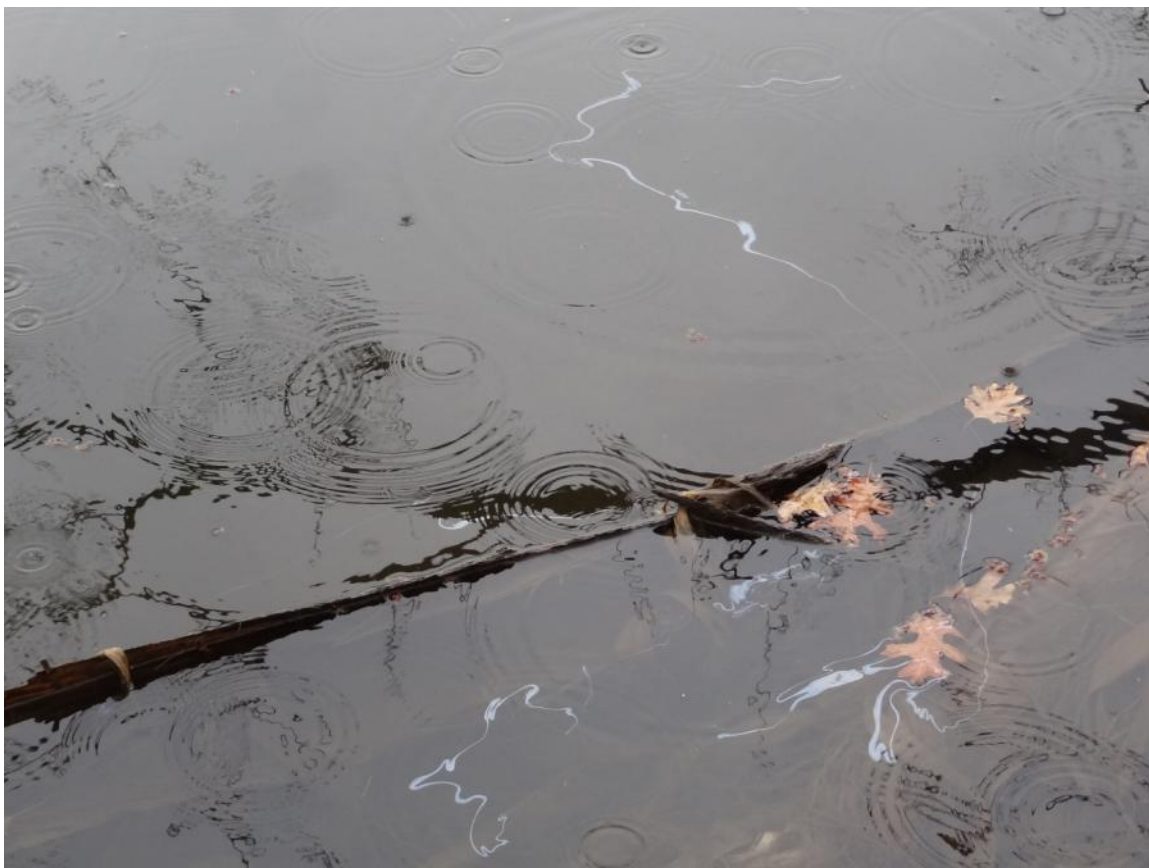
8. MP14.75 C5 Boat Launch sheen observed.

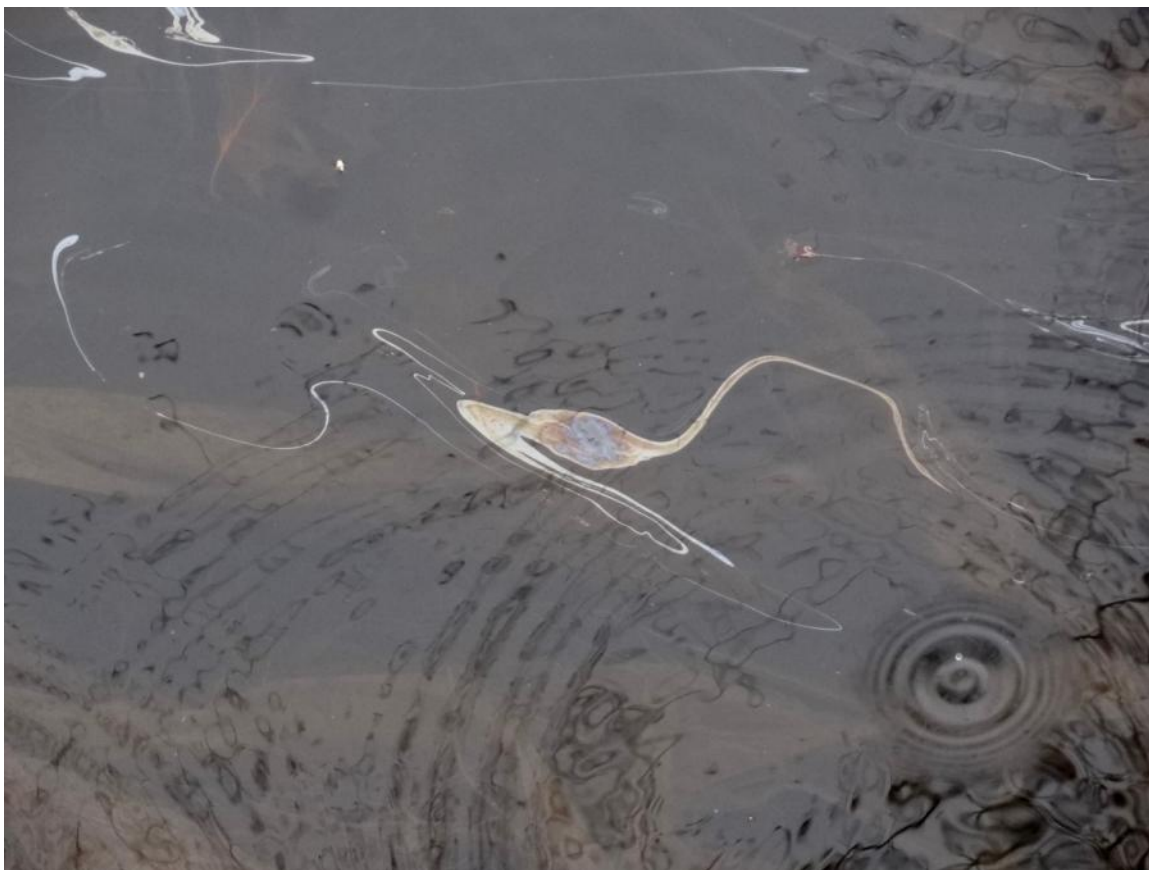
9. MP14.75 C5 Boat Launch sheen observed.

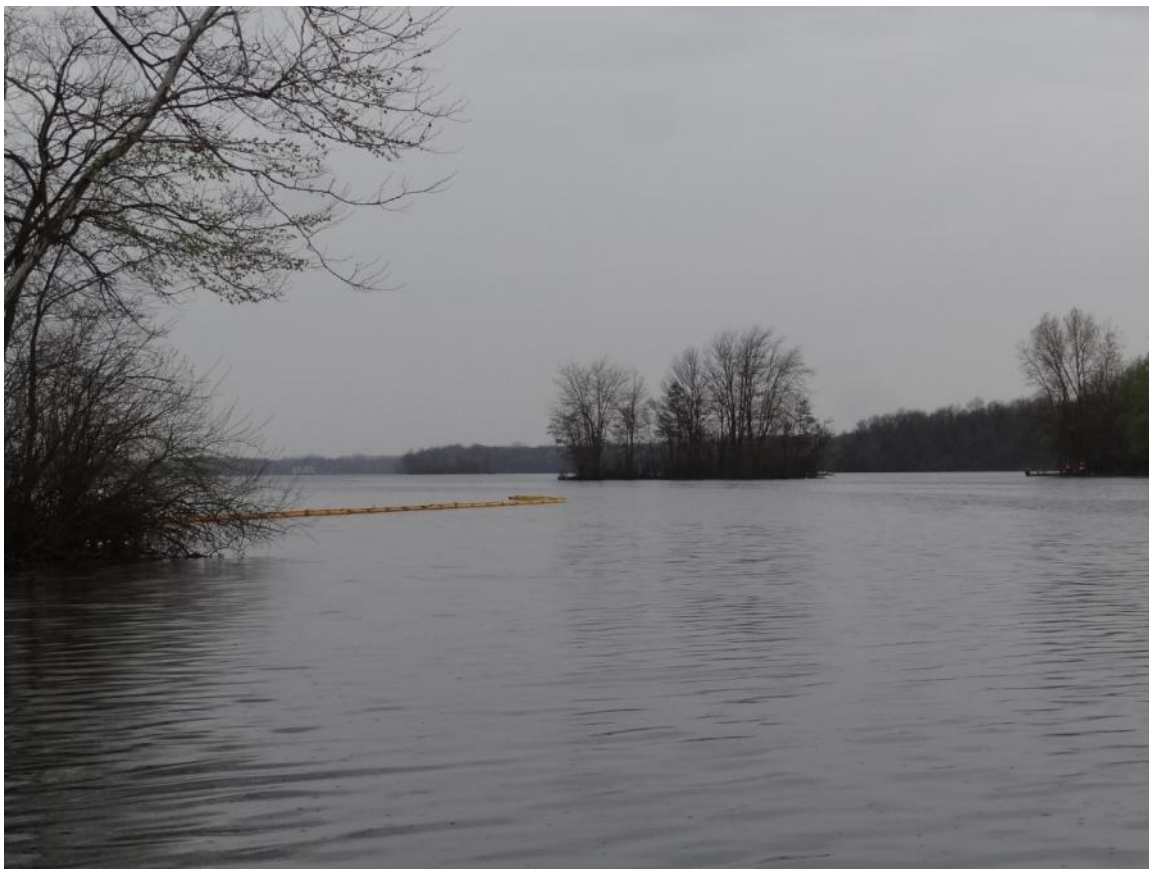
10. Morrow Lake SWAT crews observed installing E4 control point.

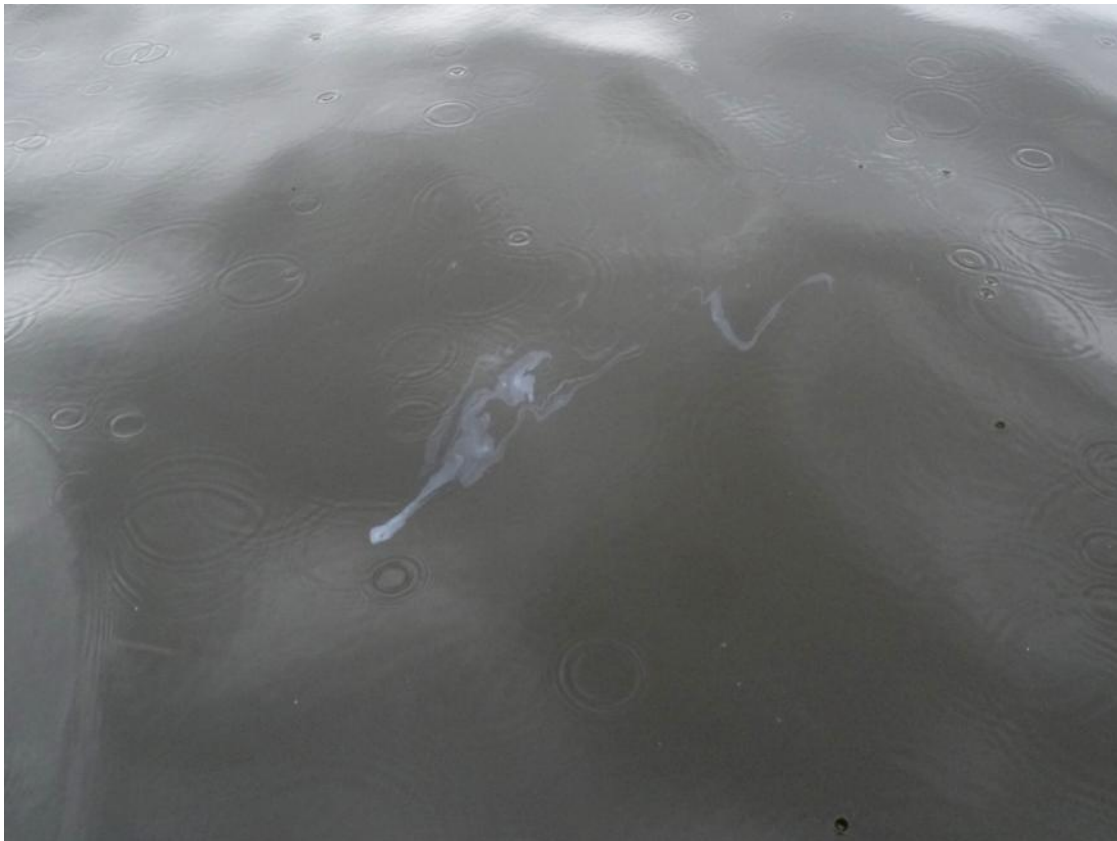
11. MP37.75 sheen observed in the center channel.

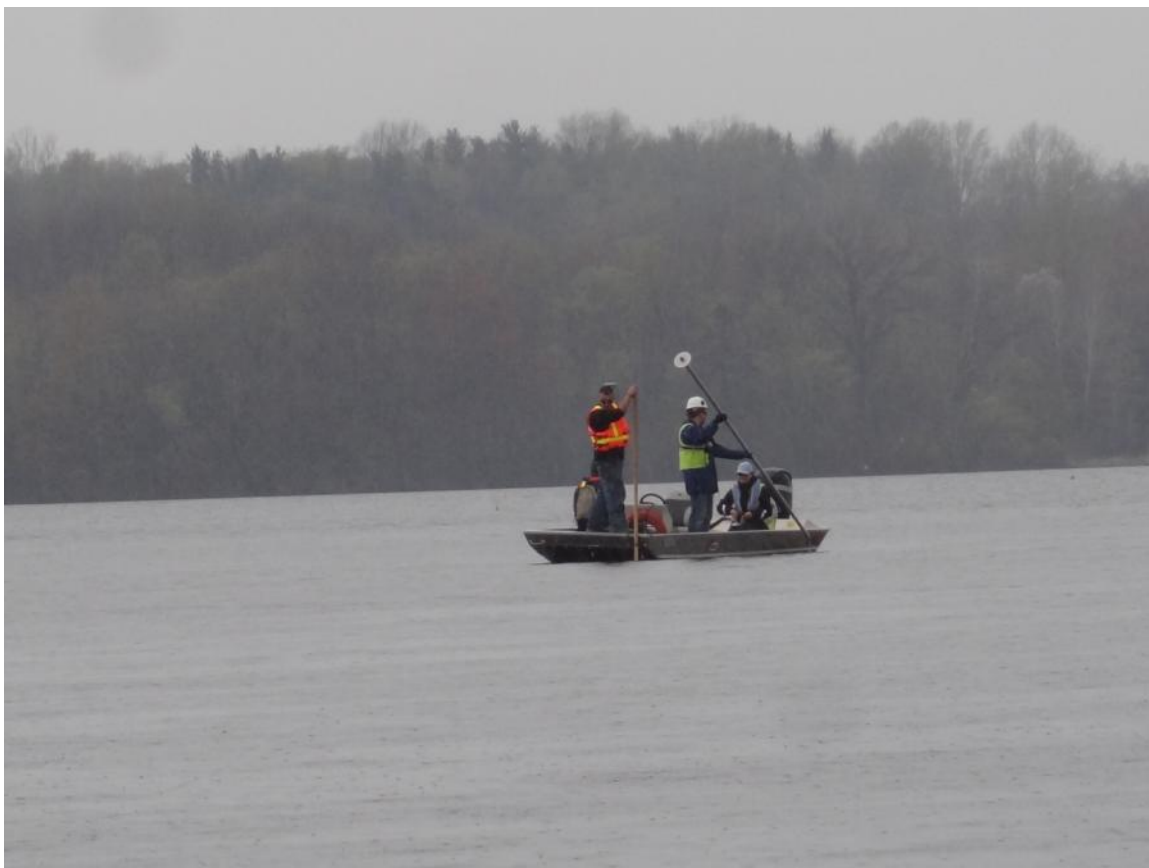
12. Morrow Lake poling crew.

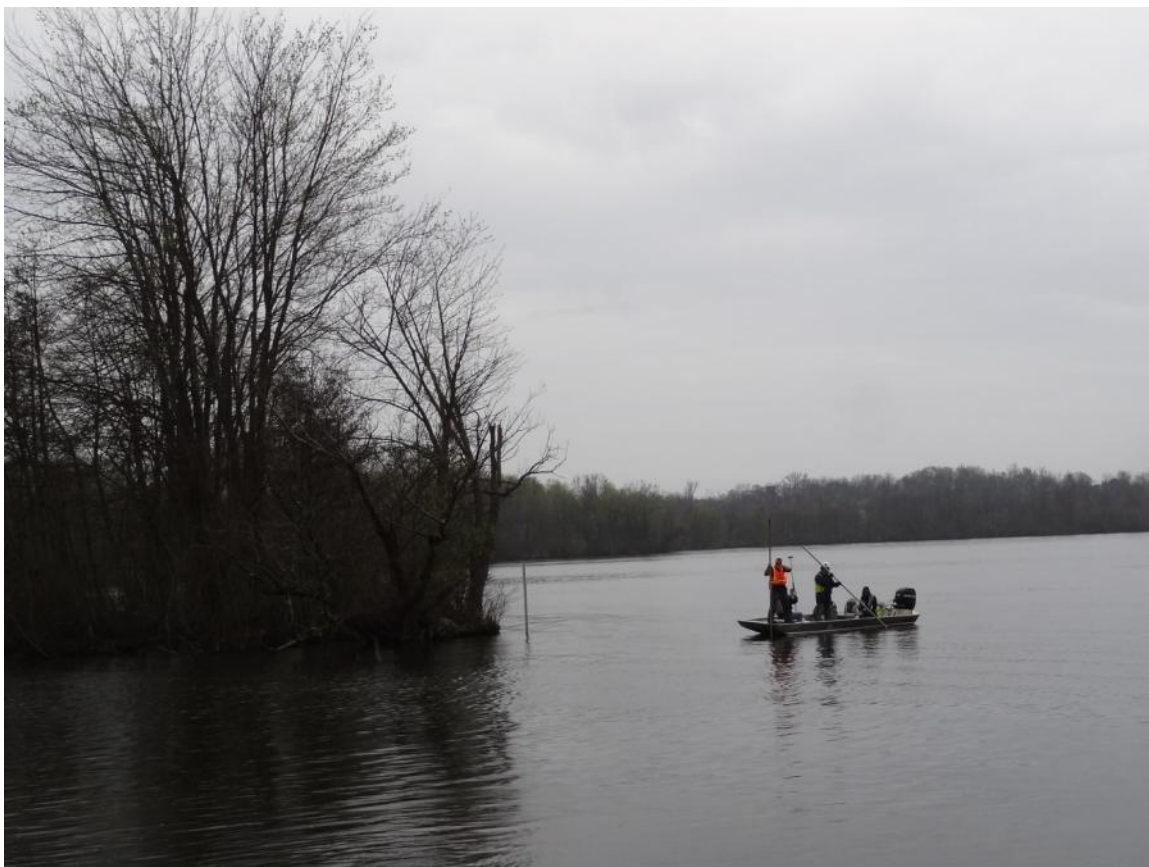
13. Morrow Lake poling crew.

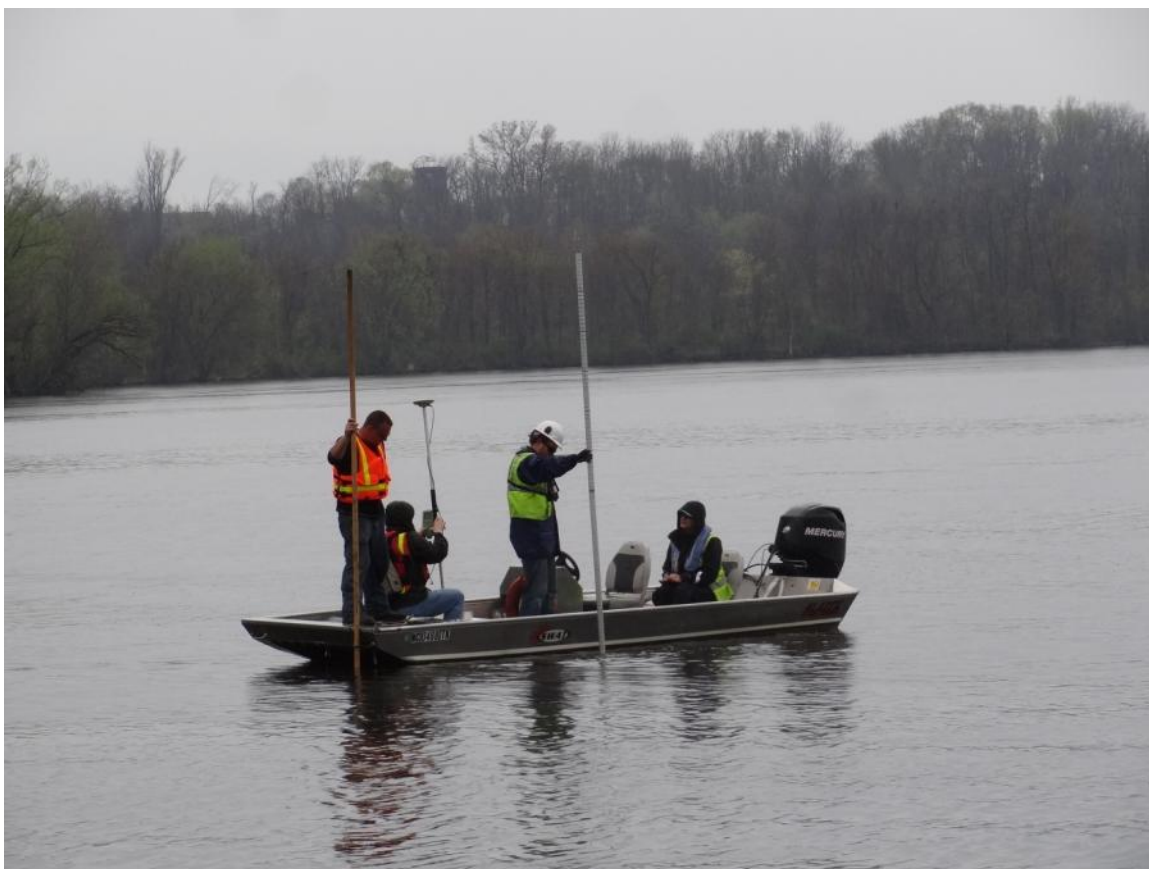
14. Morrow Lake poling crew.
